## Disaster Survey Report

That occurred during the Great East Japan Earthquake restoration  
work of the breakwater underwater explosion disaster

December 2018

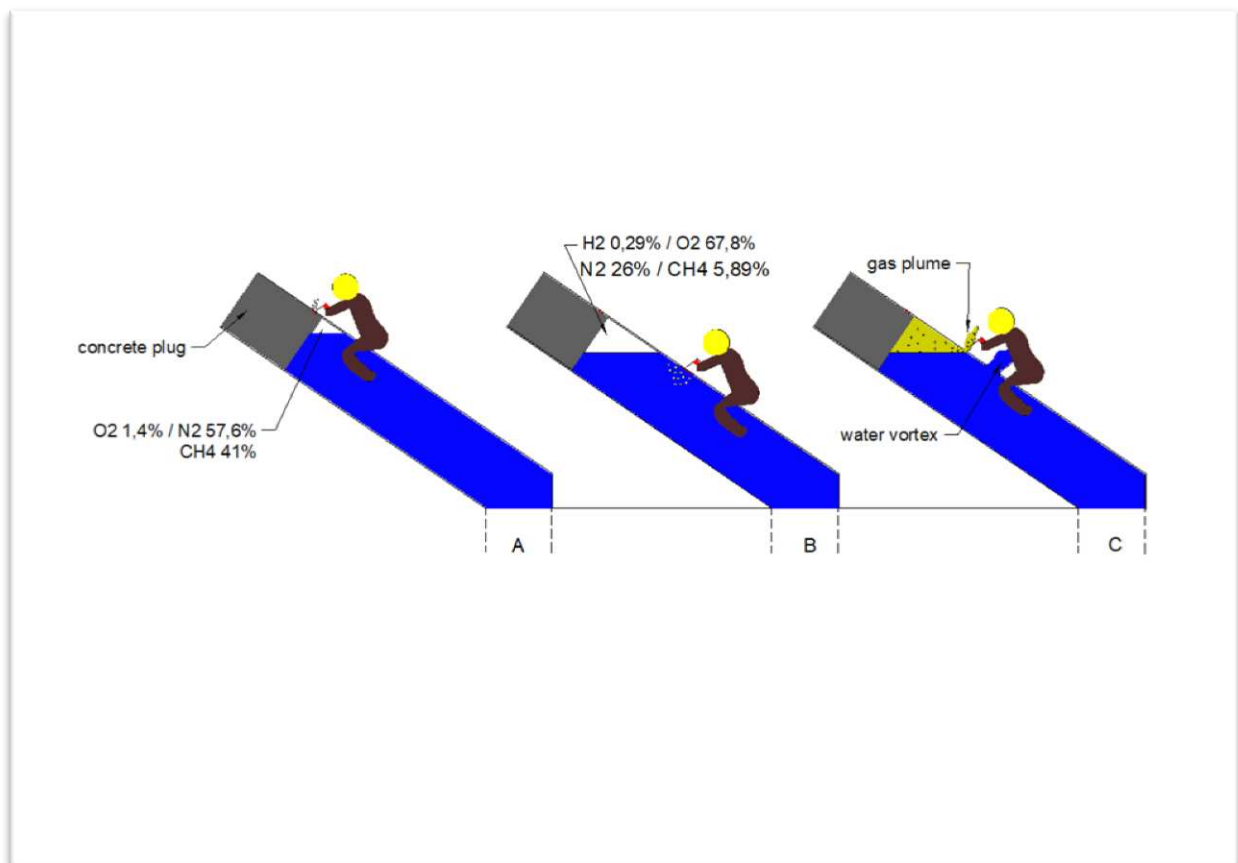
Figure n° 2: Description of the cutting sequences (illustration FH)

On this pile that had been bend during the tsunami, one (or the) diver had already tried to make a first opening at 98 cm from the top (A), but as it was still in the area containing concrete, a second hole of Ø12, 5 cm was cut at a distance of about 253 cm from the top of the pipe (B).

As this hole was too low to allow proper gas evacuation, the diver began cutting another opening approximately 62 cm above the lower hole.

As the tube was tilted, the diver was straddling the tube having his abdomen at about 50 cm from the lower hole.

Shortly after he started his cut (C), an explosion occurred in the pipe which had for effect to violently compress the surface of the water present in the pipe and project it at high speed through the lower hole where the diver's belly was over.

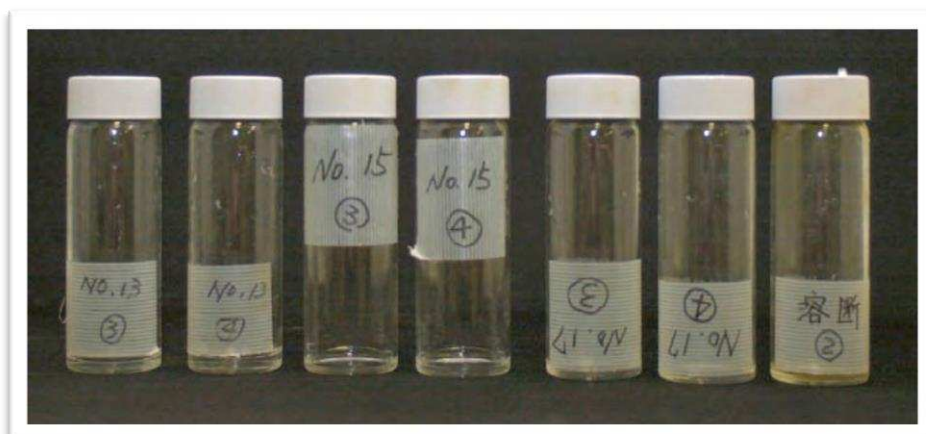
Photo n° 4: Gas samples (taken from the document)

Gas samples were taken from inside the pile prior to its recovery to surface

Based on the investigators' calculations, it was estimated that approximately 94.6 L of residual gas was still in the pile after the explosion.

The samples recovered in pile n° 13 noted that the residual gas still contained the following components:

Hydrogen (H<sub>2</sub>), carbon monoxide (CO), methane (CH<sub>4</sub>) nitrogen (N<sub>2</sub>) and oxygen (O<sub>2</sub>) (see proportion in table n° 1).

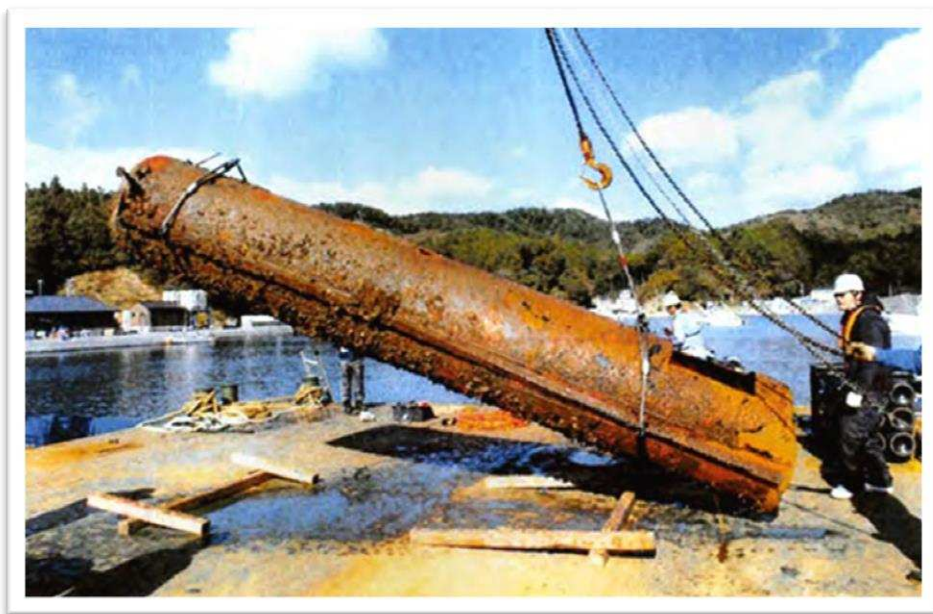
Photo n° 5: Pile n° 13 recovery (take from the document)

As soon as the n°13 pile was removed from the water, a steel plate was cut from its lower part in order to take a few pieces for the analysis of the metal structure.

According to the results obtained, the steel composition had no effect on the outbreak of the explosion.

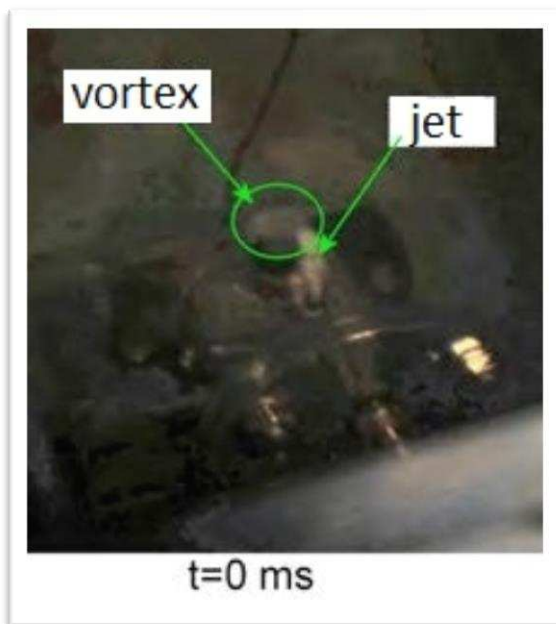
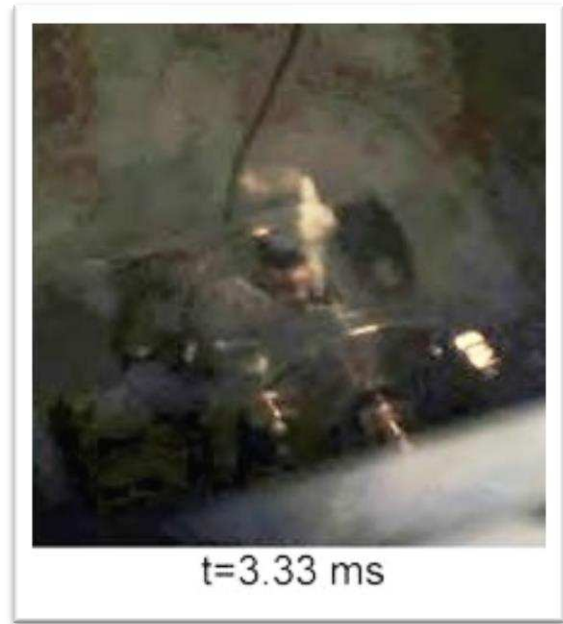
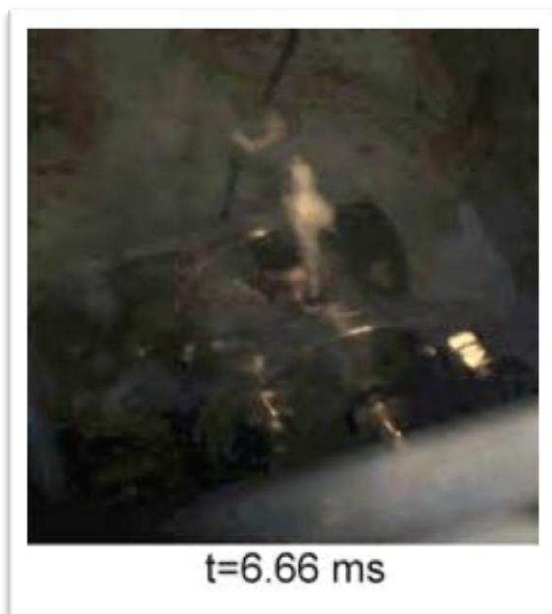
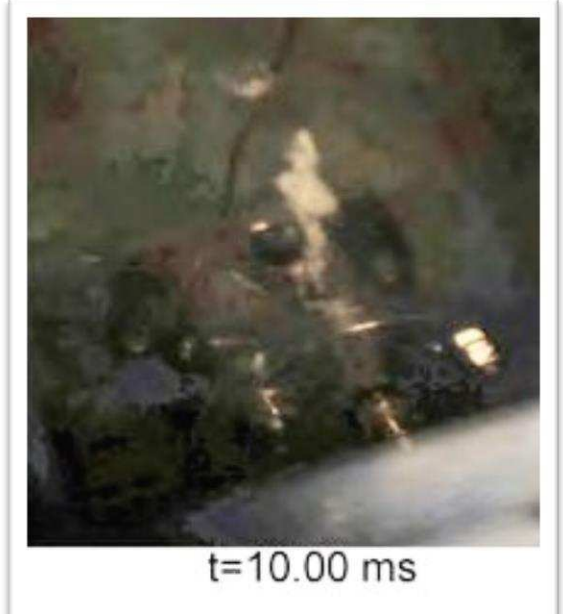
Photo n° 12 to 15: Effects of the explosion on the small tube (taken from the document)

As can be seen from the sequence of the images, at the time of the explosion, the pressurized gas and the water vortex of the lower hole were expelled extremely rapidly from the tube.

According to the various recorded measurements, the investigators calculated that due to the hydraulic ram, the diver suffered a pressure shock in his belly of around 737 kPa (7,37 bar), which was sufficient to cause irreversible internal damage.

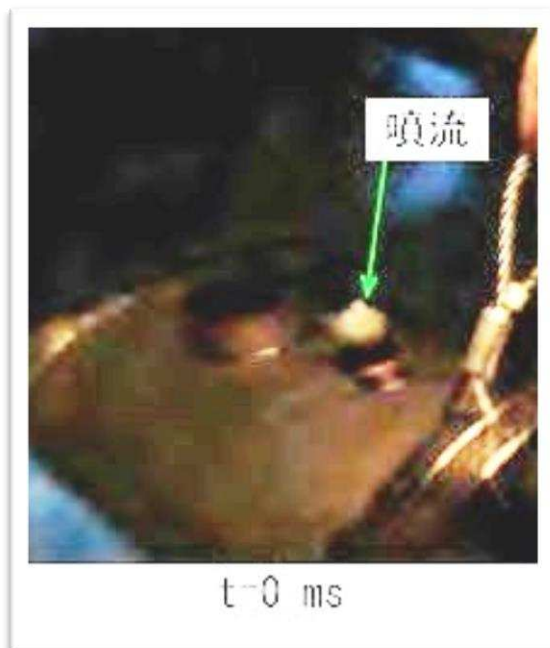
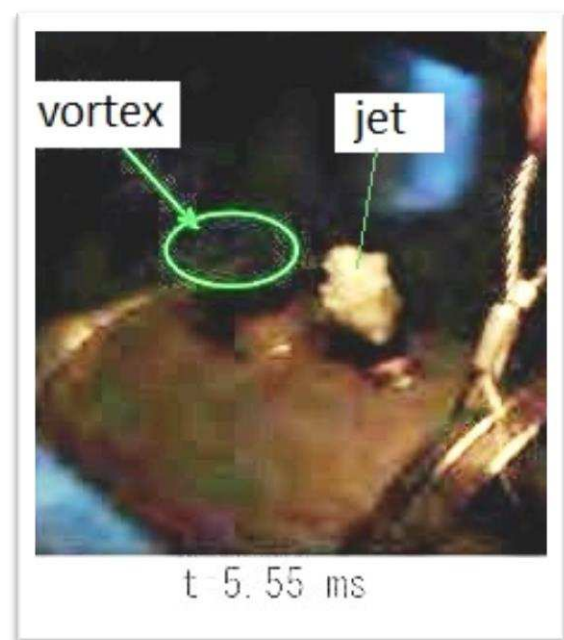
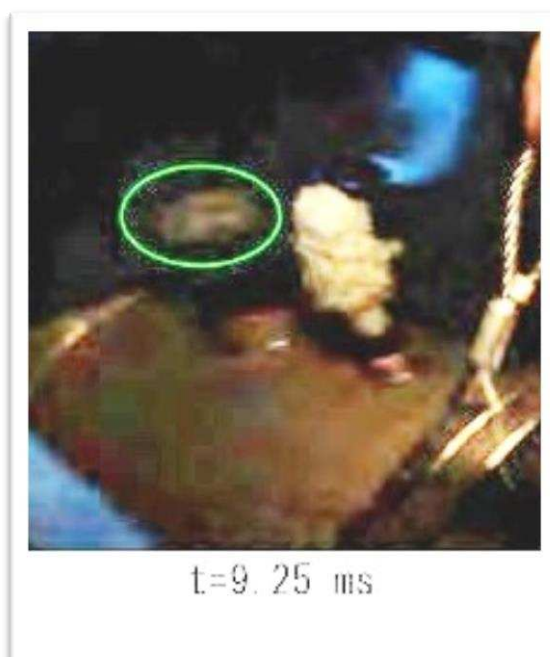
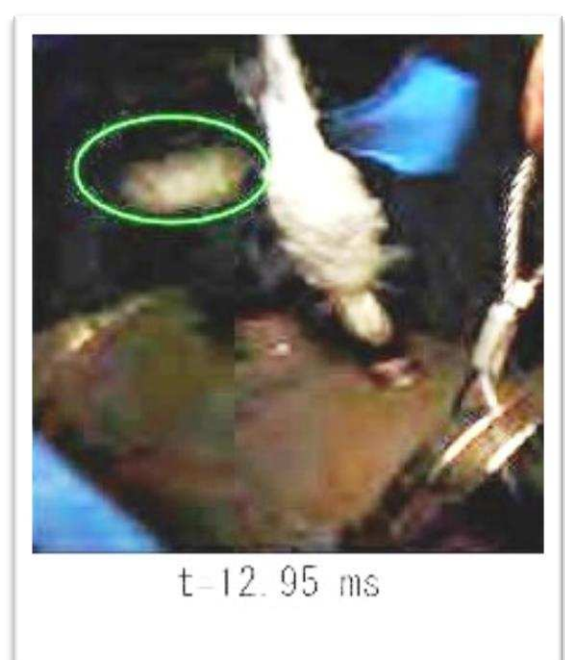
Photo n° 16 to 19: Effects of the explosion on the great tube (taken from the document)

This disaster was caused by the formation over the years of methane of geological origin. By escaping from the silt, this gas then slowly combined with the volume of air also present under the concrete plug until reaching the proportions of an explosive mixture.

The investigation concluded that in the case of similar work if it is necessary to create a ventilation hole (s) in a confined space, it must be done using a tool that does not generate any sparks.
