## Disaster Survey Report

That occurred during the Great East Japan Earthquake restoration  
work of the breakwater underwater explosion disaster

December 2018

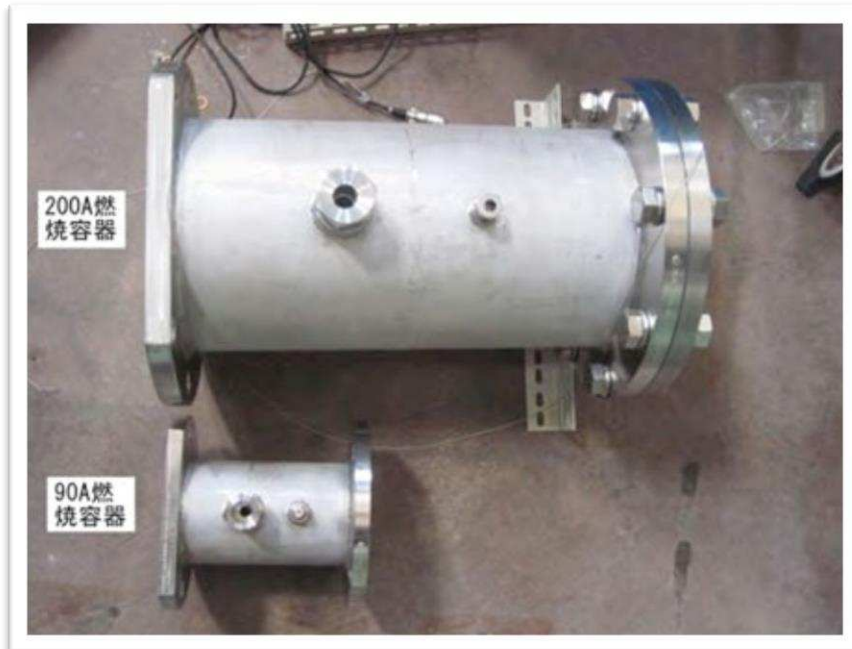
Photo n° 6: Reconstitution tubes (taken from the document)

In order to reproduce as closely as possible the circumstances of the accident, two steel tubes at scale 1 / 4.2 and 1 / 8.6 were manufactured.

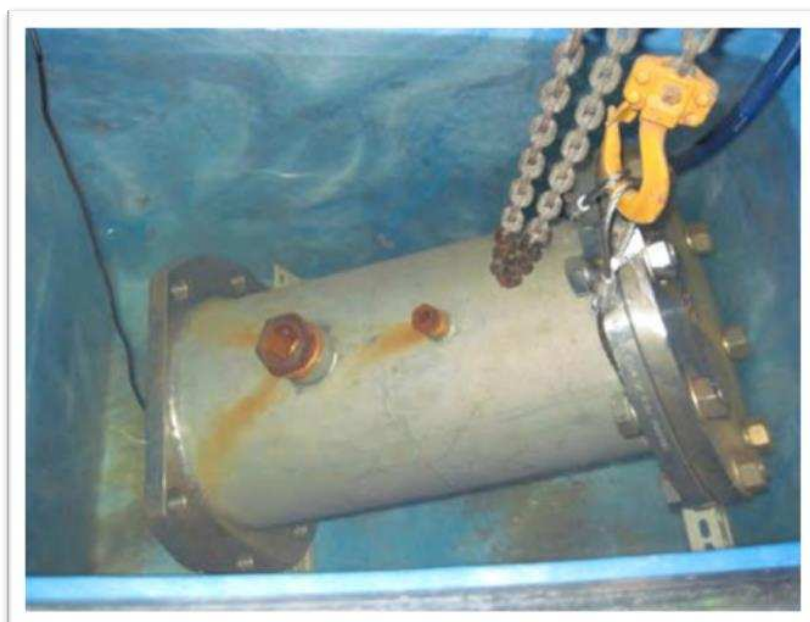
Photo n° 7: Placement in the experimental basin (taken from the document)

These were immersed in an experimental basin and filled with a mixture of gases in the following proportions:

$\text{H}_2$ : 0.299 %,  $\text{O}_2$ : 67.8 %,  $\text{N}_2$ : 26.0 %,  $\text{CH}_4$ : 5.89 (%).

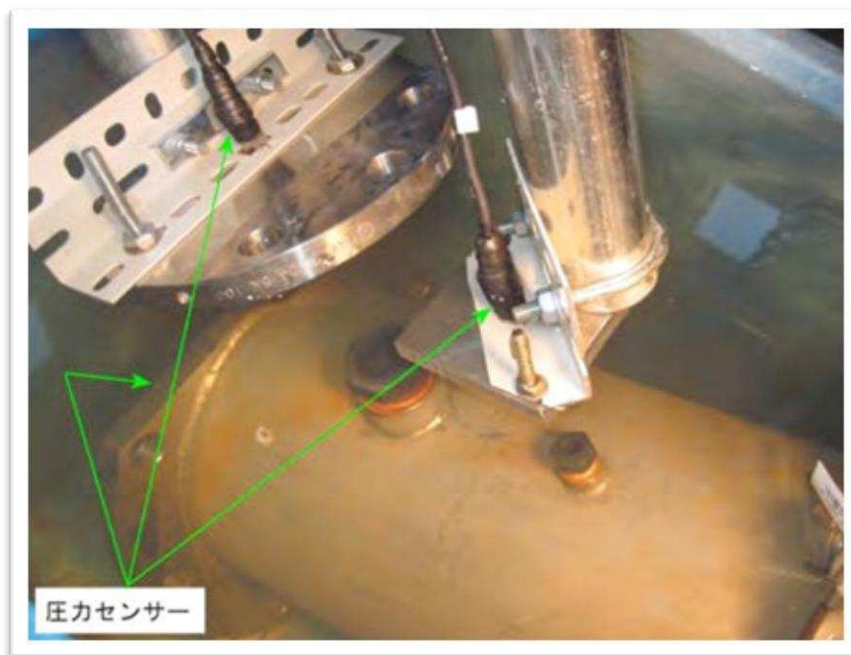
Photo n° 8: Installation of the pressure sensors (taken from the document)

Various pressure sensors were then installed at a clearly defined distance from the two openings.

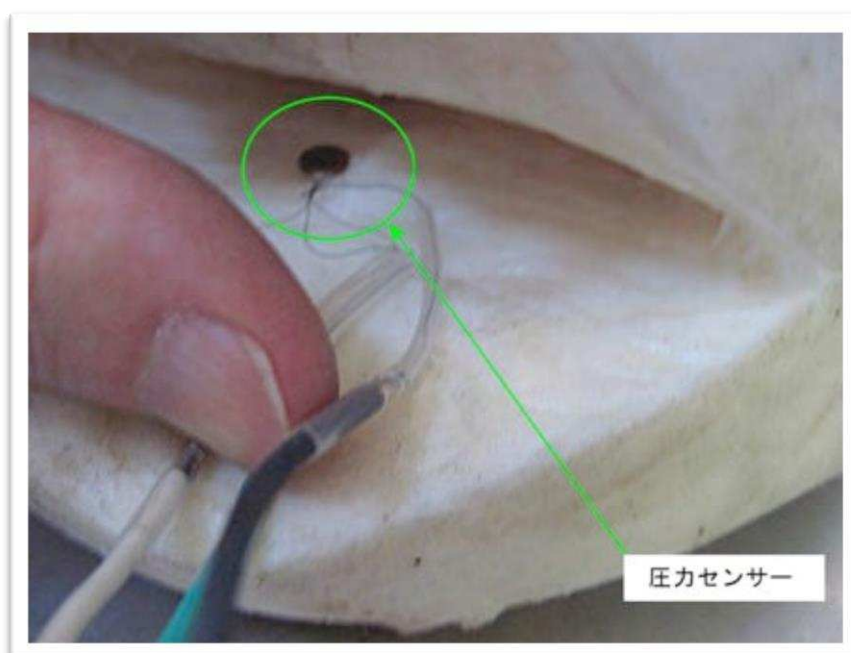
Photo n° 9: Setting of a probe in the urethane resin (taken from the document)

Finally, to best simulate the consistency and strength of the diver's abdomen, a urethane resin also equipped with a pressure sensor, as well as a thickness of 3 mm neoprene to represent the diving suit were placed in front of the biggest openings.

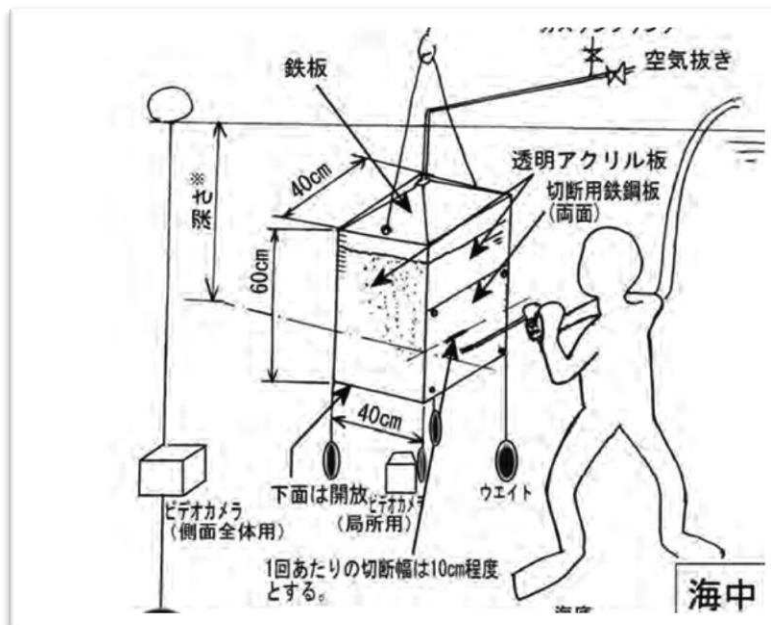
Figure n° 3: schematic view of the gas recovery test

Two cameras were also placed on the sides of the box in order to be able to visualize how the incandescent slags and the gases at the back side of the steel plate evolved.
